# RESTORING THE OPERATIONAL CAPACITY OF A COUPLED-LOOP MOLASSES DESUGARIZATION SEPARATOR

David R. Groom<sup>1\*</sup>, Heather Jarski<sup>1</sup>, Terry D. McGillivray<sup>1</sup>, Mike Goettel<sup>2</sup>

<sup>1</sup>American Crystal Sugar Company, 1700 North 11th Street, Moorhead, MN 56560, <sup>2</sup>American Crystal Sugar Company, 121 Highway 81 NE, Hillsboro, ND 58045

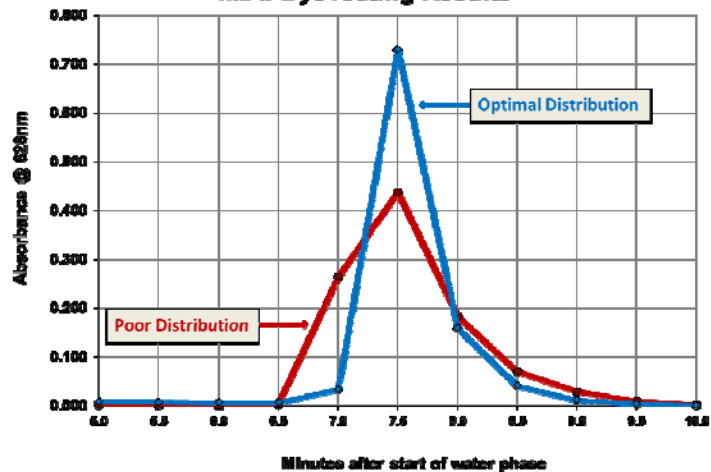
**Figure 3  
MDS DyeTesting Results**

1. Resin in the cells must be uniformly distributed. There should be a minimum of broken beads or resin fines present. Results: We found that the cells were uniformly packed and a minimum of resin fines were present. Dye testing results were poorer than expected after backwashing resin.

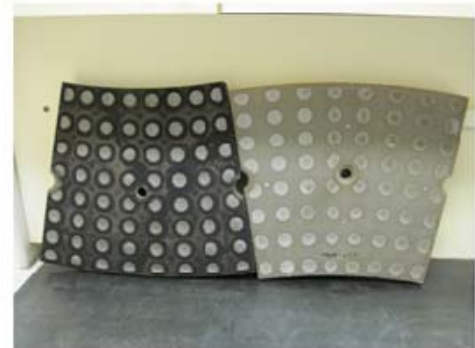
Some fractals were soaked in a mild acid (2% HCl) solution; others were soaked in a mild (2%) caustic solution. The most effective cleaning was realized with the caustic solution. The photo below-right shows the material that was flushed out of one upper fractal plate after it

had been soaked in a 2% caustic solution (room temperature) for 1 hour. While it appeared that the upper fractals were fouled, it was unknown to what degree the fouling impacted performance of the fractal plates. In order to assess the plates, a testing apparatus (test cart) was built. The test cart pumped water through a fractal plate; flow rate and pressure were monitored. Data were collected on pressure drop across a fractal plate at a given flow rate. With fractal technology turbulent flow was not expected. We monitored fluctuations in pressure, which are an indication of turbulent flow. New plates, upper plates that had been in service and lower plates that had been in service were tested. Pressure was monitored at flow rates that ranged from 3 to 8.5 gallons per minute.

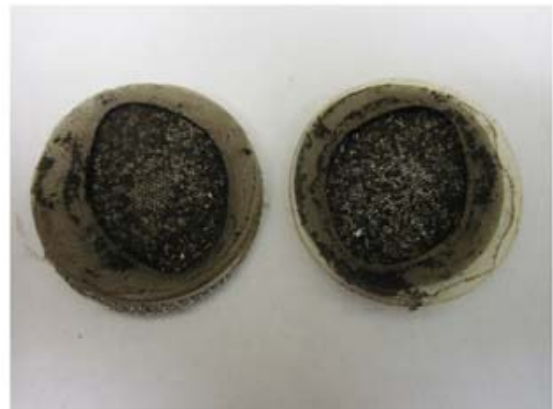
Fouled upper fractal plates were cut open to view internal fouling. Distributor screens were removed to view the inside of the screens and the scale in the ports. Port diameter was reduced up to 15% in the upper fractals that had signs of fouling. Scale and debris on the screens was considerable. The photo to the right shows the interior of two screens that had been removed from an upper fractal plate. Roughly half the open area of each screen was blocked with debris. Port diameter (at the screen) of a new fractal is 0.096 inch; screen size is typically 0.875 inch.

Photomicrographs were also taken of screens removed. To the right is a photomicrograph (30X) of the inside of a screen removed from an upper fractal. Backlighting was used to identify open area in the screen. The majority of what should be open area is covered with scale and debris that is consistent with the appearance of calcium oxalate.

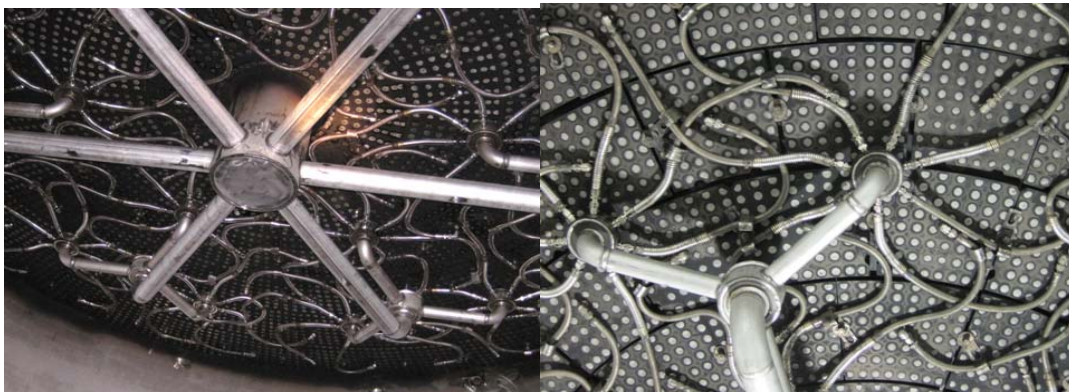
Below are photos of the upper distribution headers before (left) and after (right) pressure washing. In the photo of the cell before pressure washing notice the brownish-black material present on the fractal plates, hoses, and distribution pipes. Anywhere from two to four hours were required to pressure wash the upper distribution system.

Based on the results obtained in the pilot plant setting, a method for cleaning up the fractals was exported to the Hillsboro factory site. First, a cell in the second loop was isolated and the resin removed to a backwash tank. After the cell was cooled and ventilated, the upper fractals were pressure washed in place with 1200 psi water. A nozzle was used that provided a fan spray pattern.

After the upper fractal plates were cleaned, the cell was closed up. Hot soft water was run into the cell at a rate of 1000 gallons per minute in an up-flow mode; normal flow through the upper fractals is in the down-flow configuration. Back-flushing of the cell continued for 30 minutes. During the back-flushing routine it was not unusual to see floor drain area covered with debris that had been removed from the distribution system. During distributor clean-up, resin was also thoroughly backwashed.

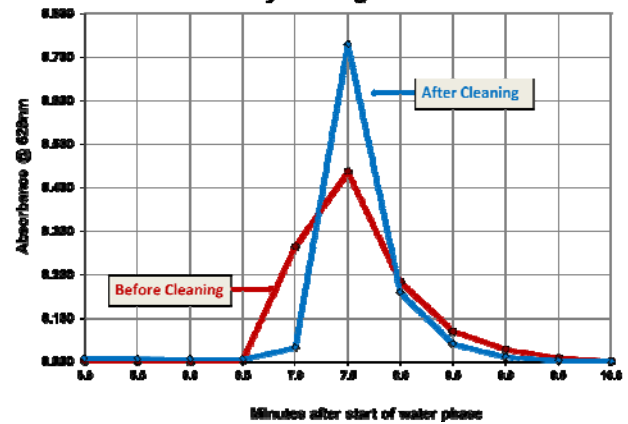
**Figure 5**  
**MDS Dye Testing Results**

Follow up dye testing was completed on several cells in the second loop. Earlier in this paper a graph (Figure 3) representing results of dye testing illustrated the difference between poor fluid distribution and good distribution. The graph shown on the right (Figure 5) was based on data

collected from a cell before and after the upper fractals were pressure-washed and the resin backwashed; the same data displayed in Figure 3 earlier. This reinforces the improvement in internal fluid distribution realized when fractals were pressure washed before backwashed resin was introduced into the cell.

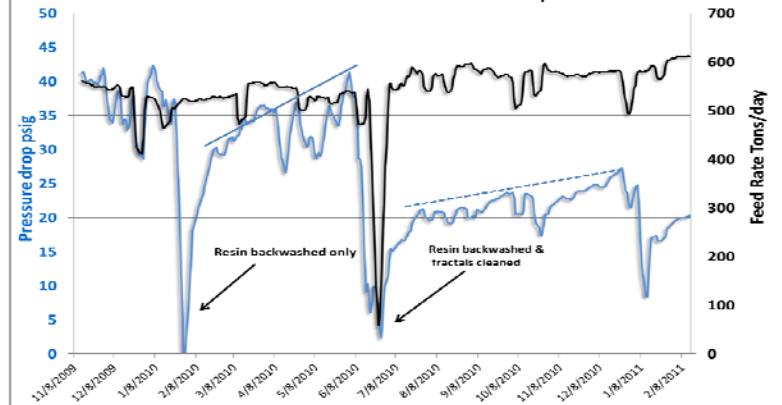
**Figure 4**  
**Feed Rate and Cell Pressure Drop**

Pressure drops decreased dramatically in each cell that was pressure-washed while the resin was backwashed. Typically the average pressure drop across the cell dropped from 40 psi to 10 psi. The addition of pressure washing and back-flushing to the maintenance routine decreased pressure drops by as much as 60 percent. High operating pressure shutdowns that had become routine became non-existent and remain so today. Since operating pressures decreased, step time could be shortened up to match the nonsugar load coming into the facility. Better sucrose recovery was realized while throughput was increased by 12 percent. The facility now operates above rated capacity (600 tons per day) by several tons per day. Downtime due to pressure shut-downs is now nonexistent; shutdowns for resin trap servicing have also been reduced. In Figure 4 to the right, processing rate of standard molasses (black line) is shown along with pressure drop across a cell (blue line). On the left side of the graph, note the rather rapid increase in pressure drop after backwashing the resin only. In contrast, on the right side of the graph, note that the increase in pressure drop over time is much slower when the fractals are pressure-washed while resin is backwashed. Before pressure washing was implemented, the pressure drop across a typical cell increased from 20 psi to 40 psi in about 8 weeks. When a cell's fractals were pressure-washed while resin was backwashed, initial pressure drop was lower. Average pressure drop increase (12 to 24 psi) was over 11 months of operation versus the 20 psi increase observed in 2 months prior to the new maintenance routine. Also note the increase in processing rate that was realized when fractal cleaning was done.
