EXPERIENCES WITH A PUTSCH JET WASH ROLLER TABLE

Kevin Bloom
American Crystal Sugar Company,
Box 357, 1020 Business Highway 2,
East Grand Forks, MN 56721

**Kevin Bloom
Production Superintendent
American Crystal Sugar Company
East Grand Forks, MN**

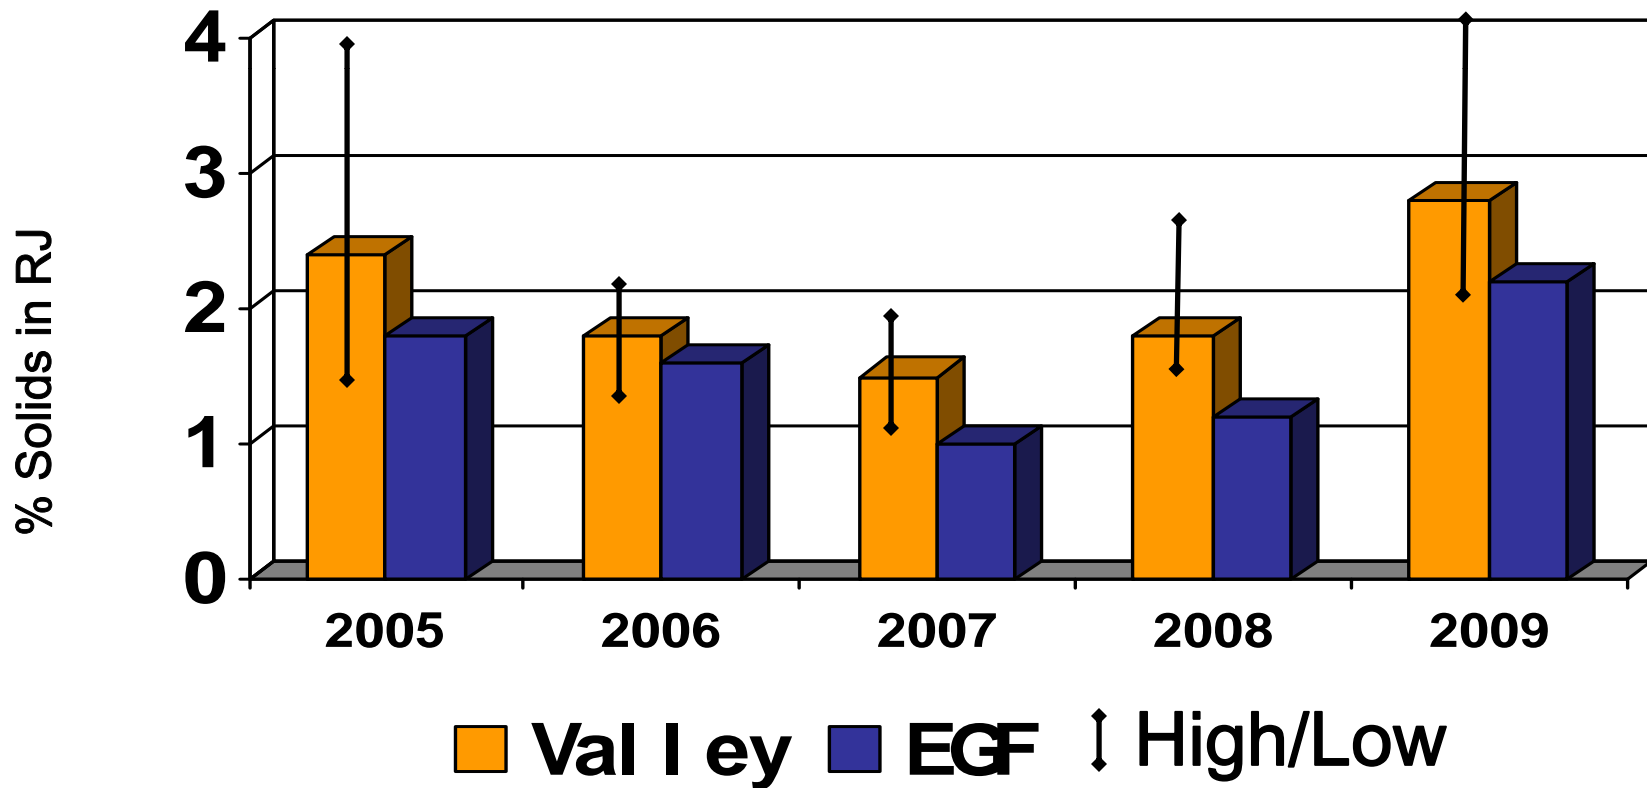
BEET WASHING EFFECTIVENESS

Raw Juice Solids Comparison
