2011 ASSBT

**Mini-Cassia Factory
Mud System Development**

Evolution of a Solution

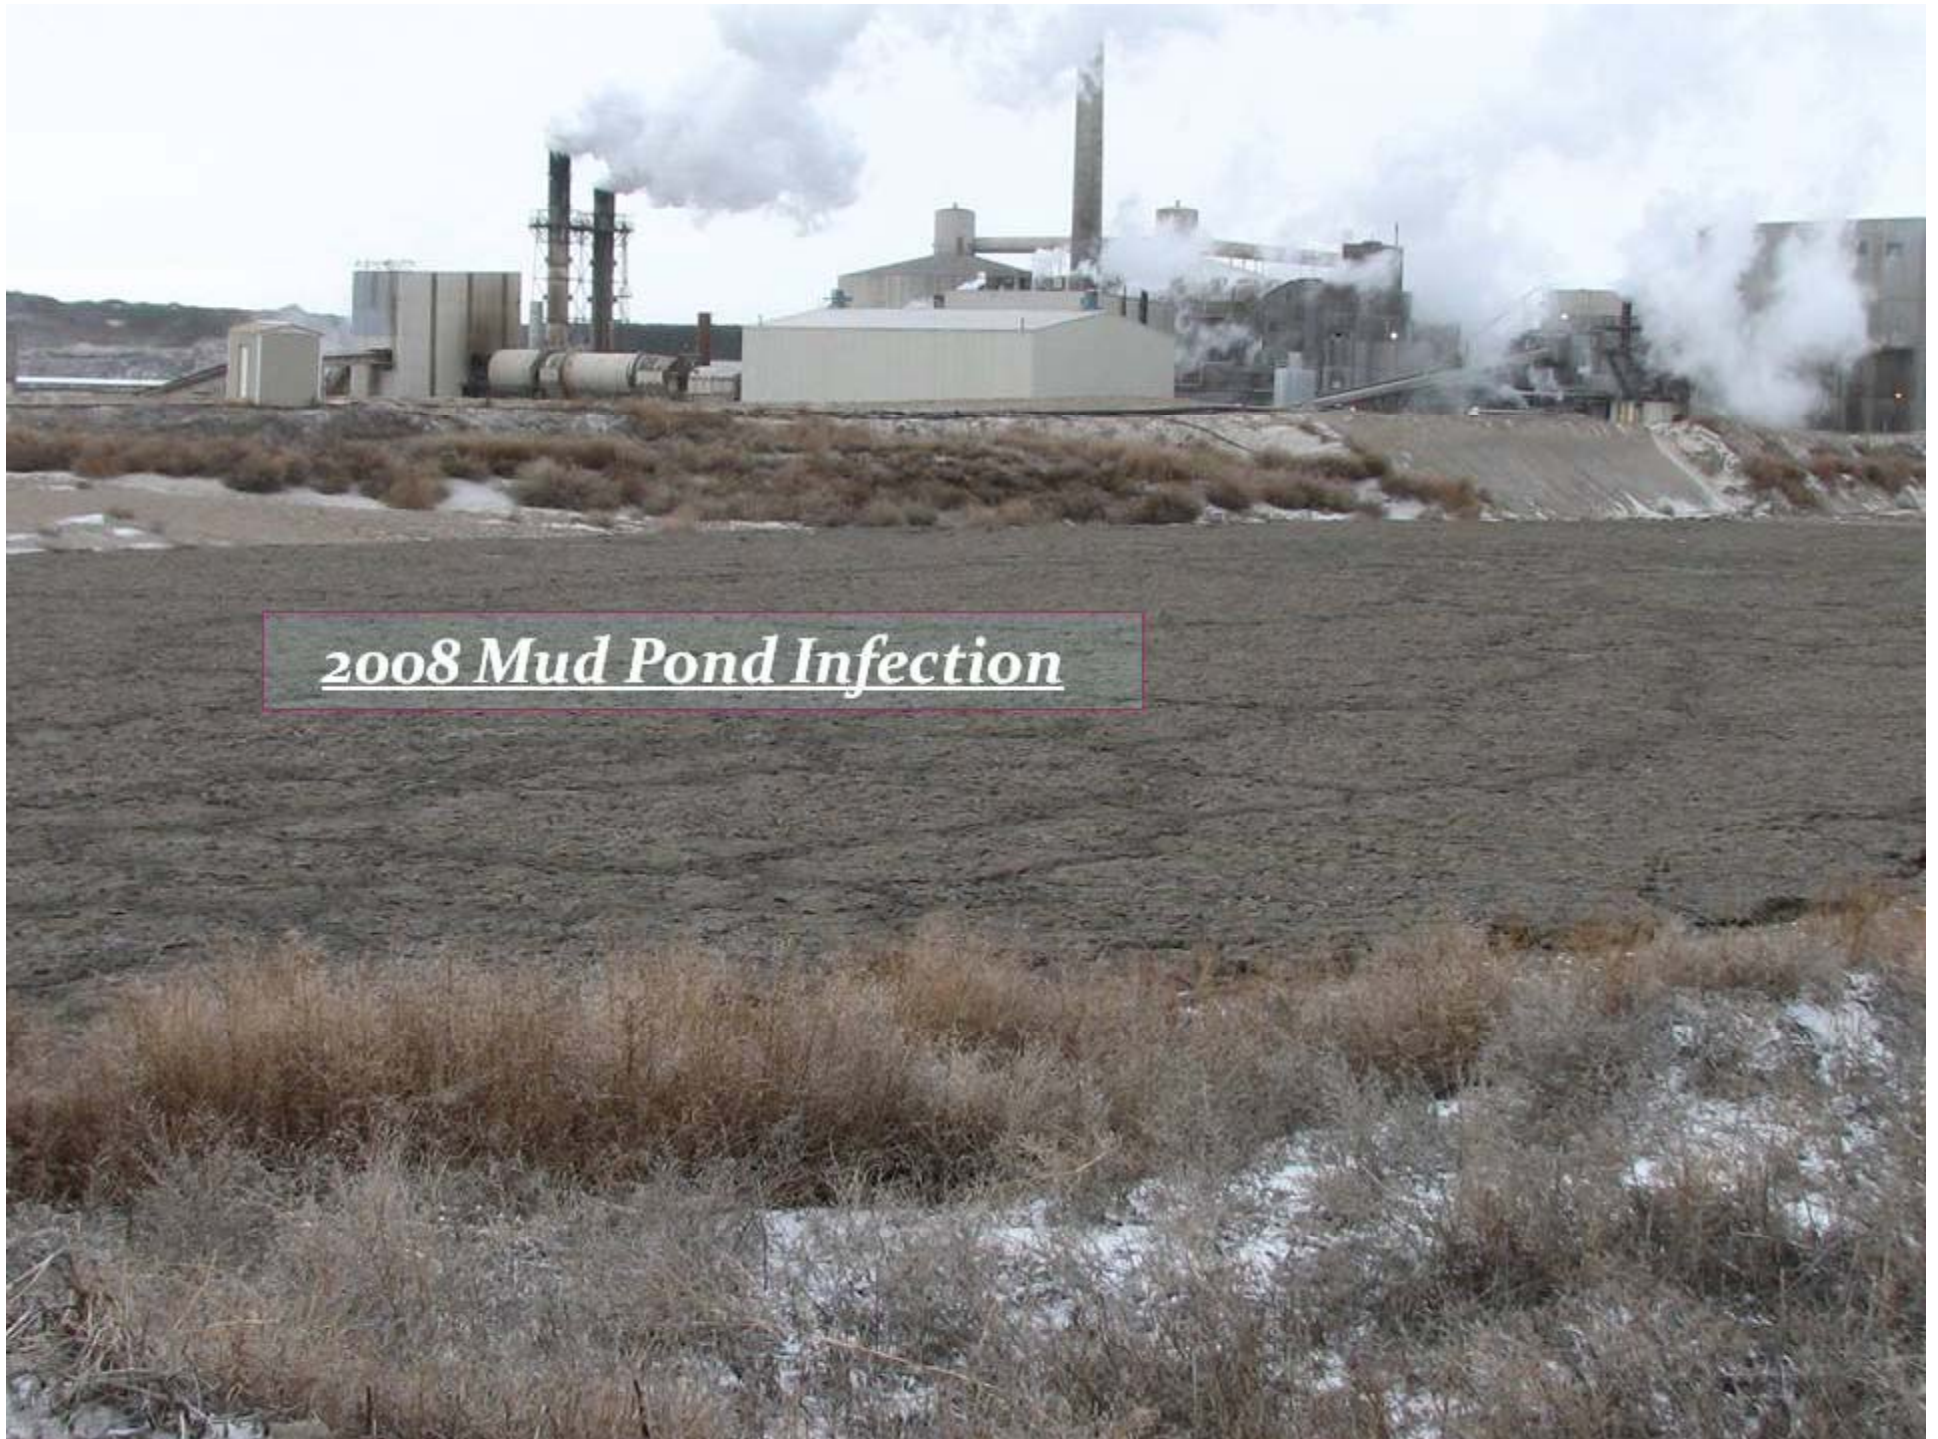
2008 Mud Pond Infection

A photograph of a large, dark brown, textured mud pond. The surface is uneven and appears to be covered in a thick layer of foam or silt. In the foreground, there is some dry, yellowish-brown grass. A white text box with a thin black border is centered in the upper half of the image, containing the text "Foam on top of mud pond".

Foam on top of mud pond

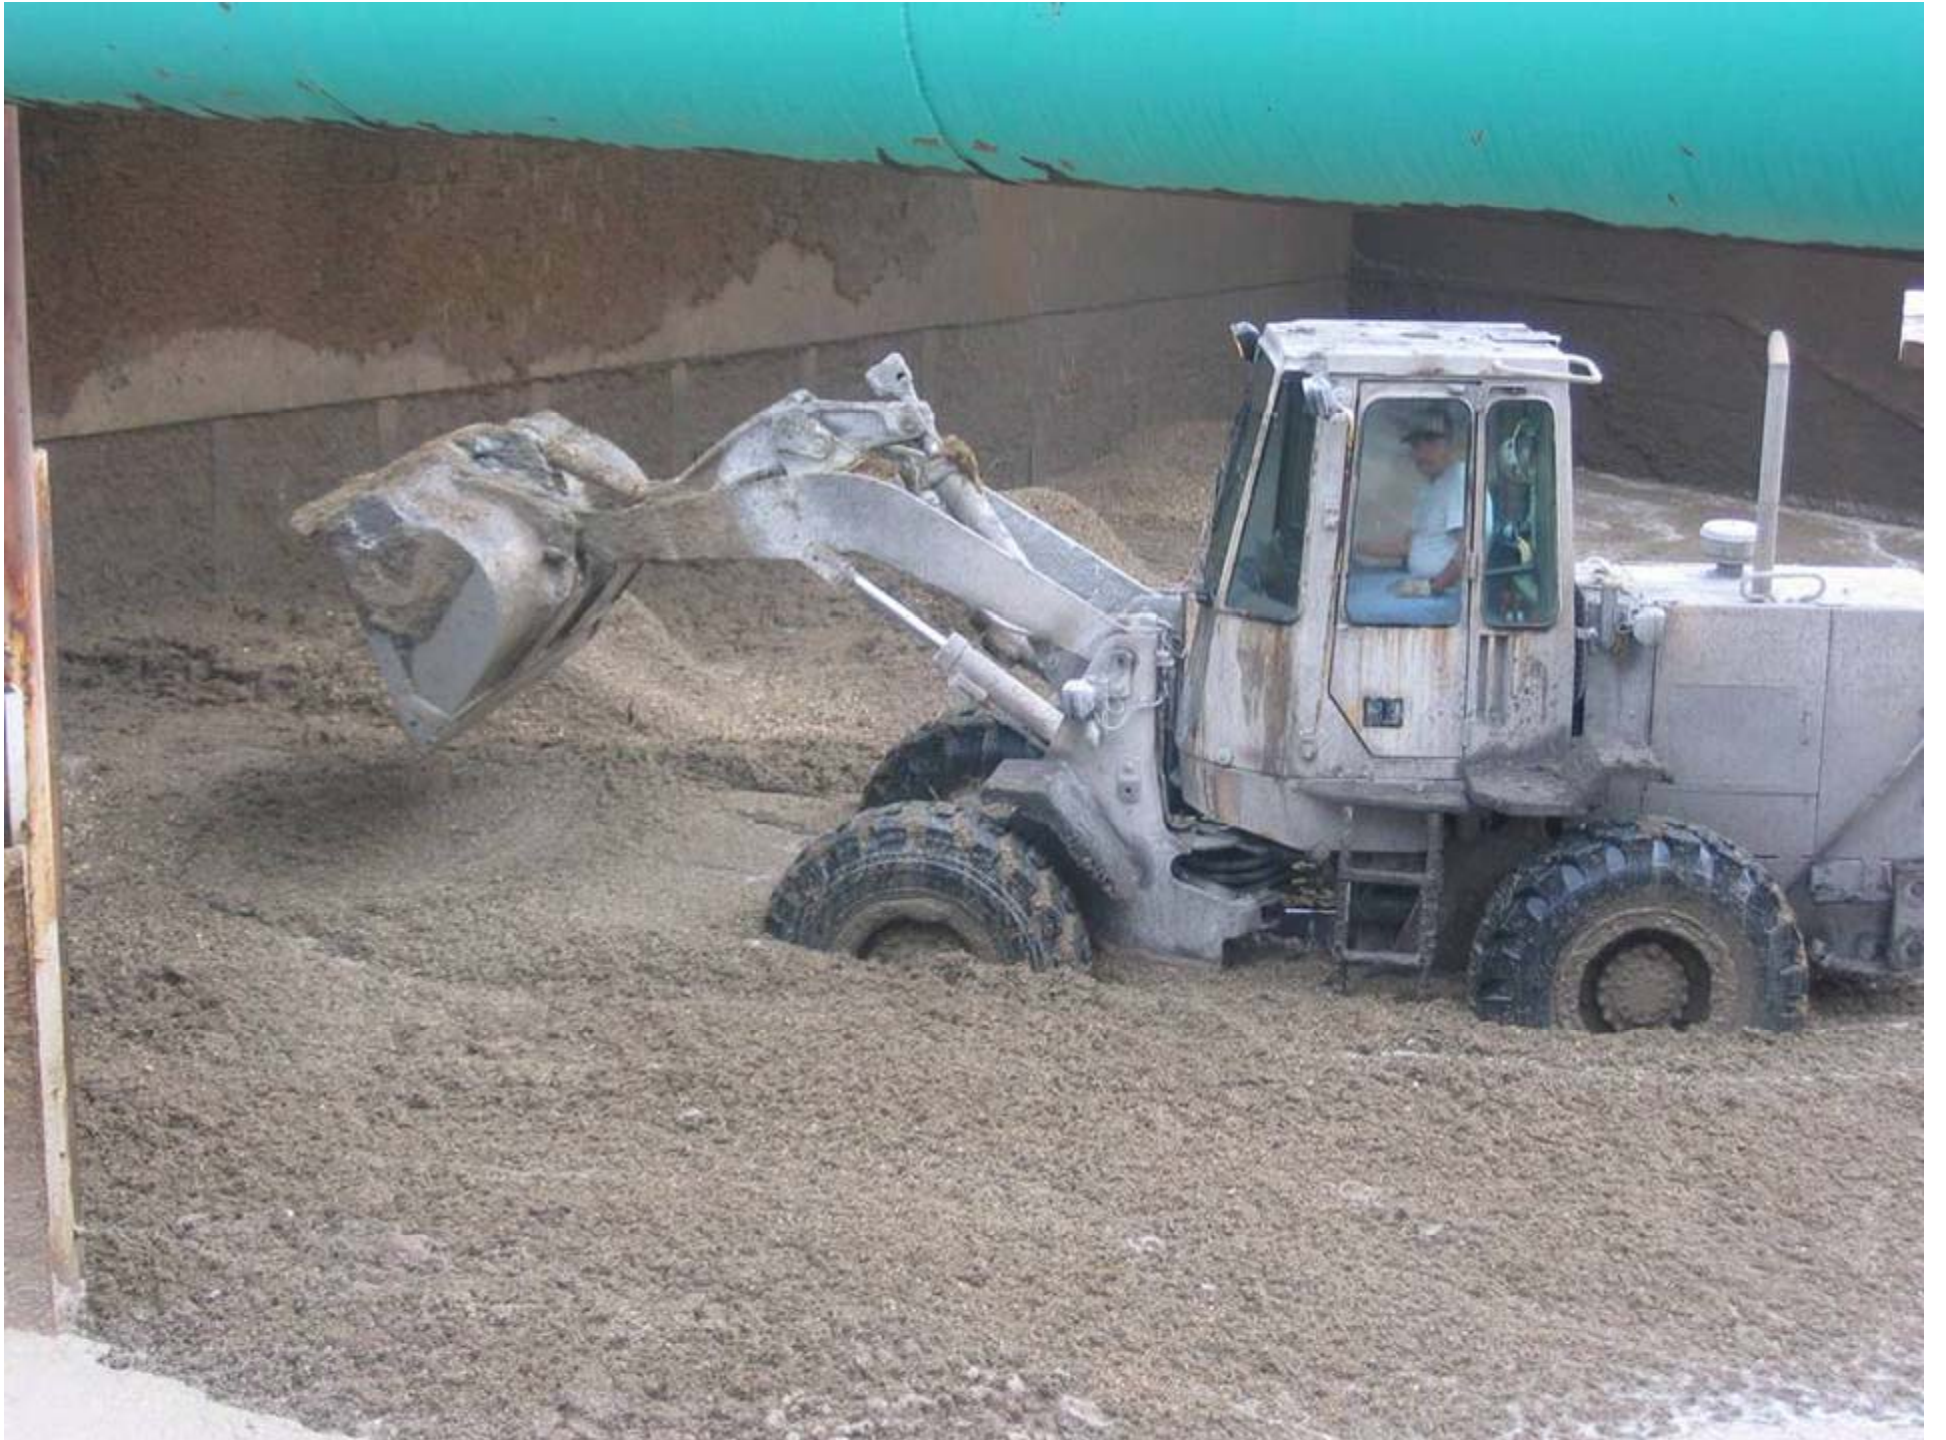
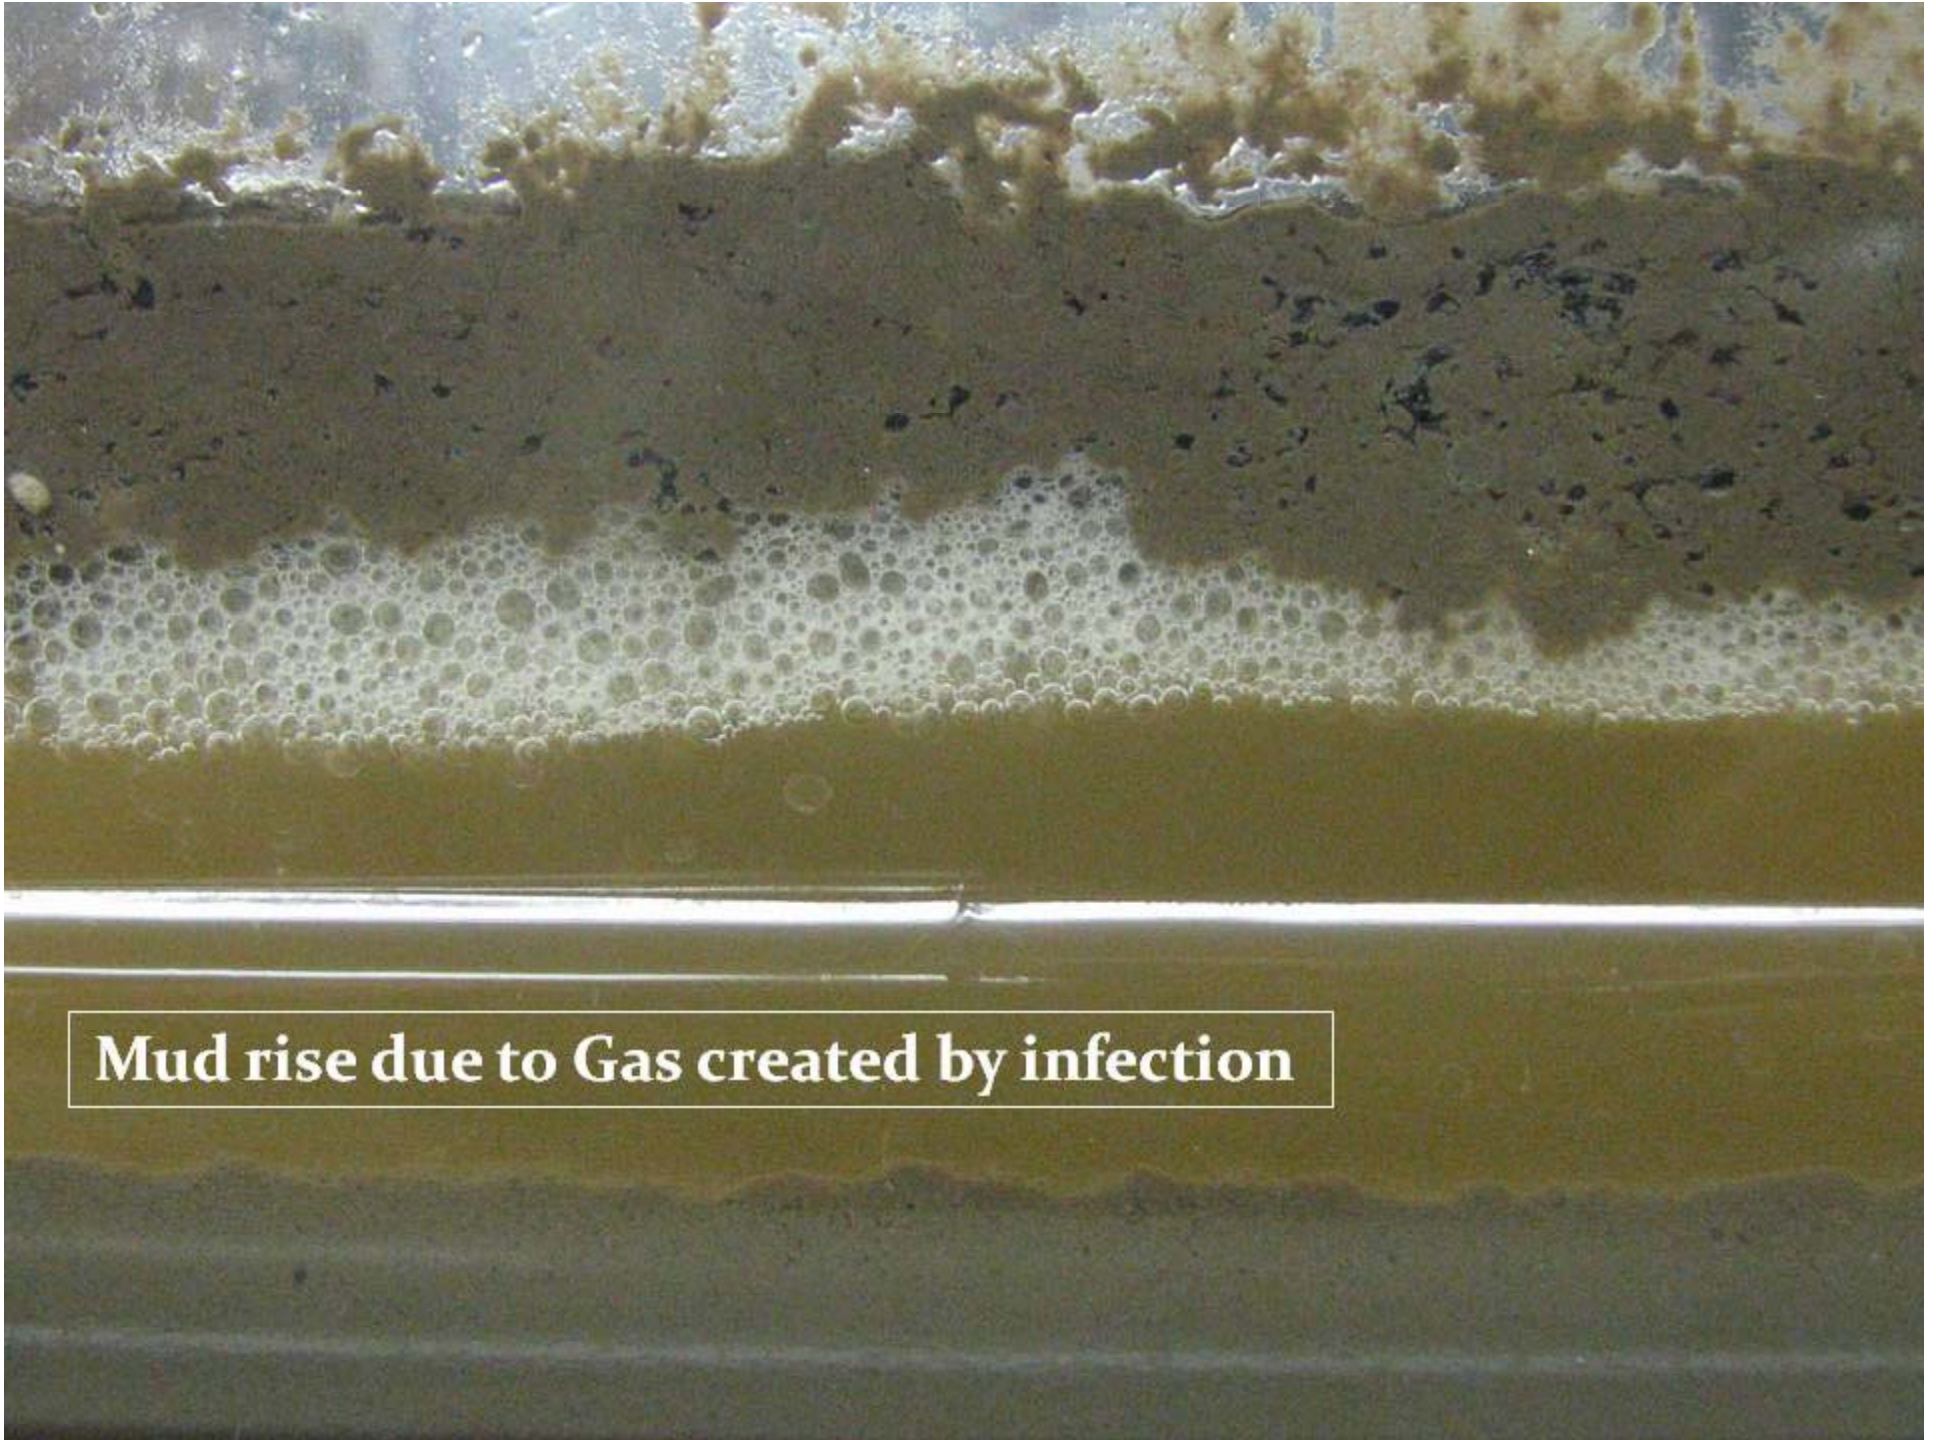
Mud rise due to Gas created by infection

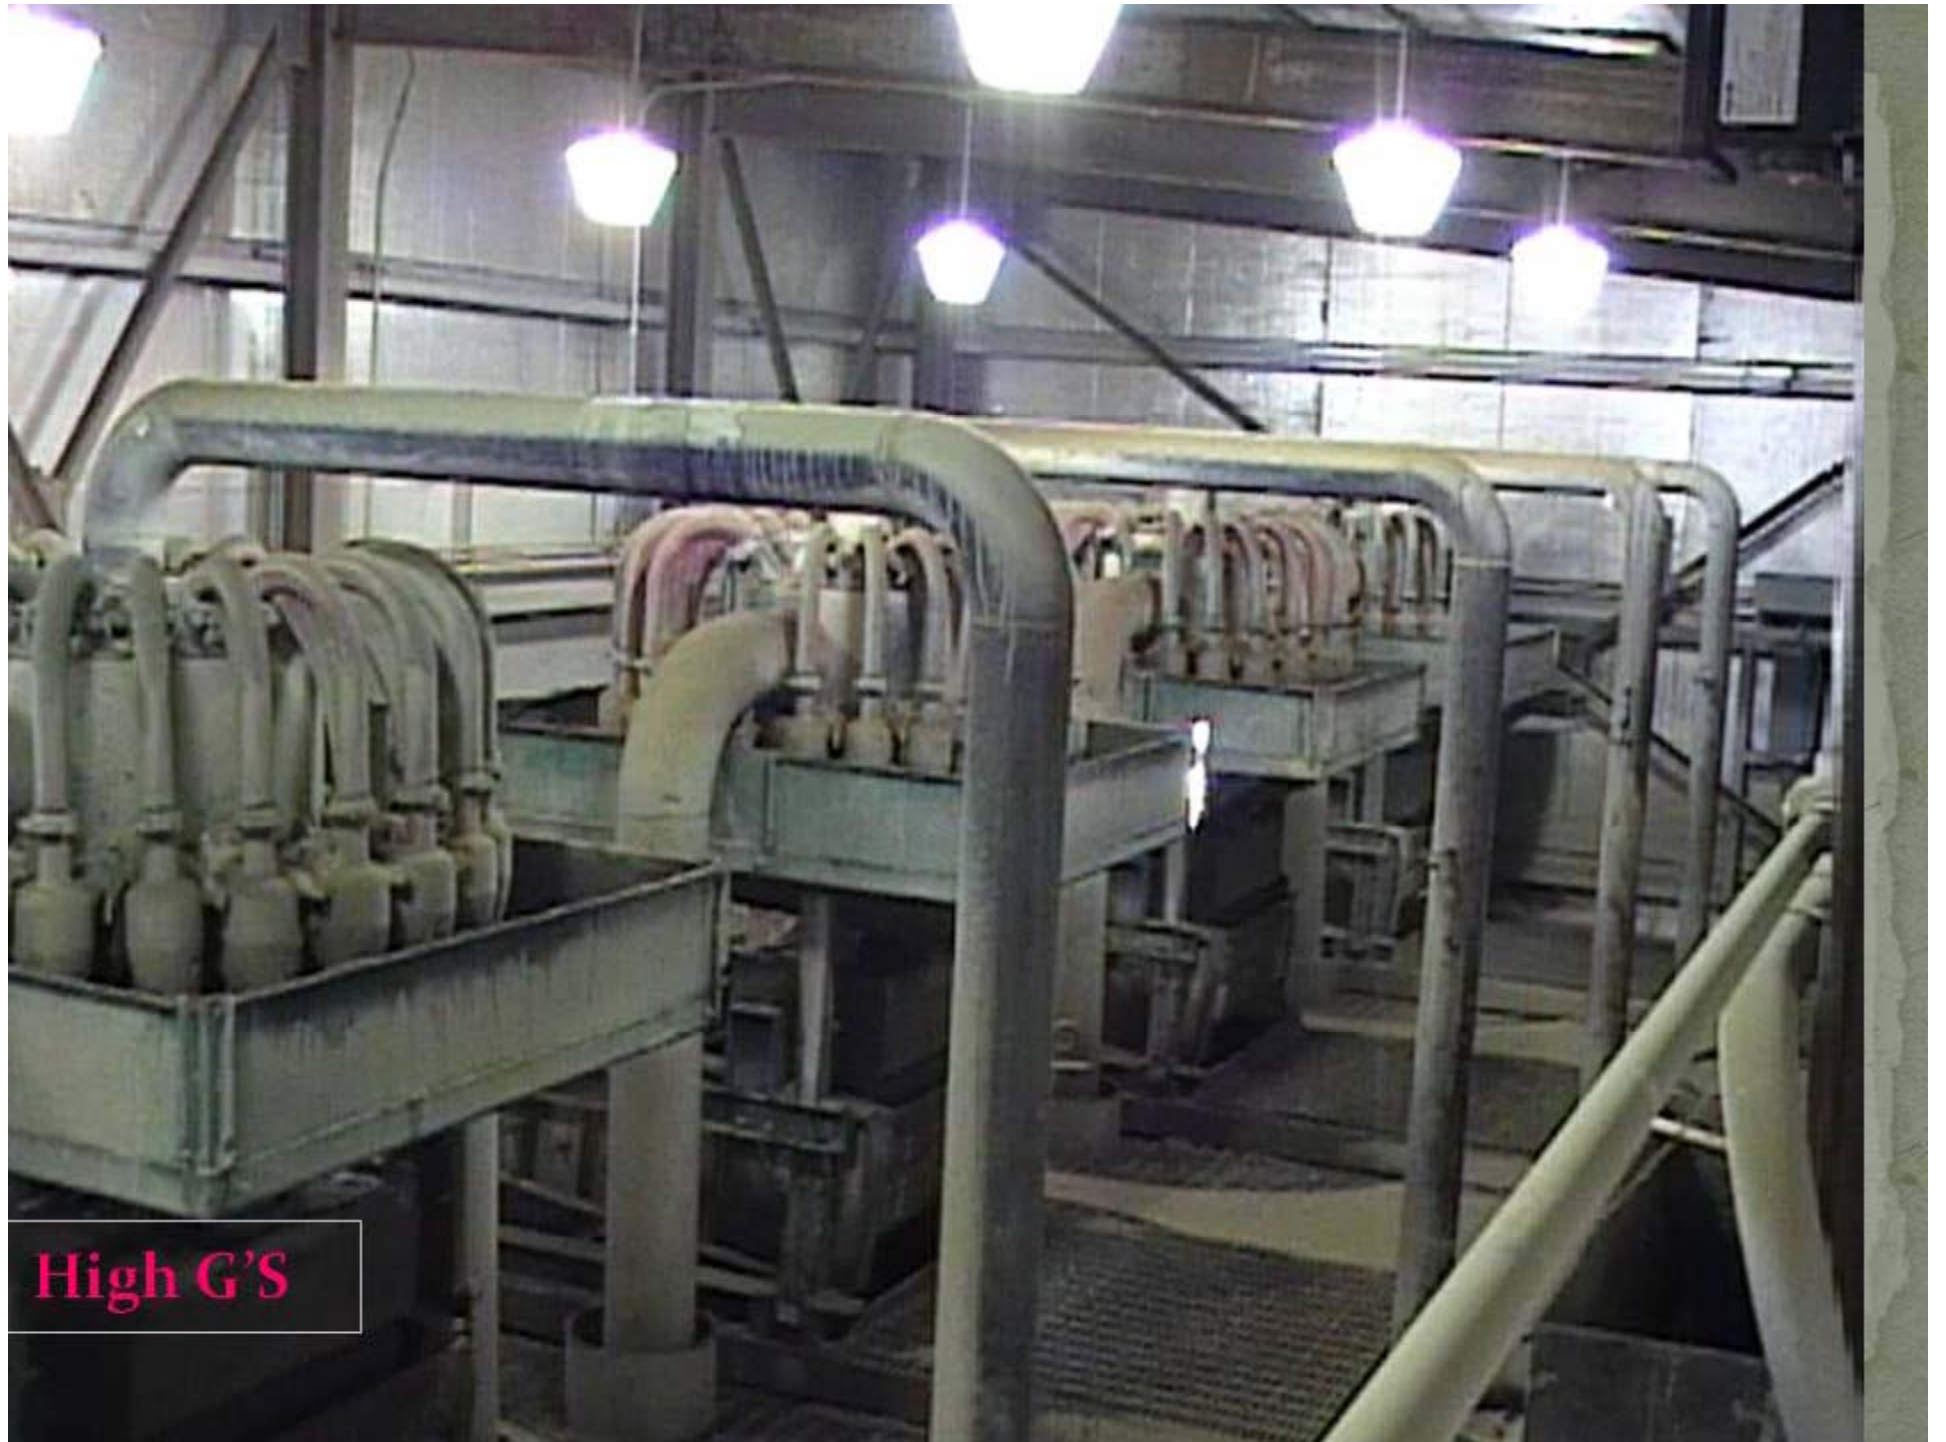
High G'S

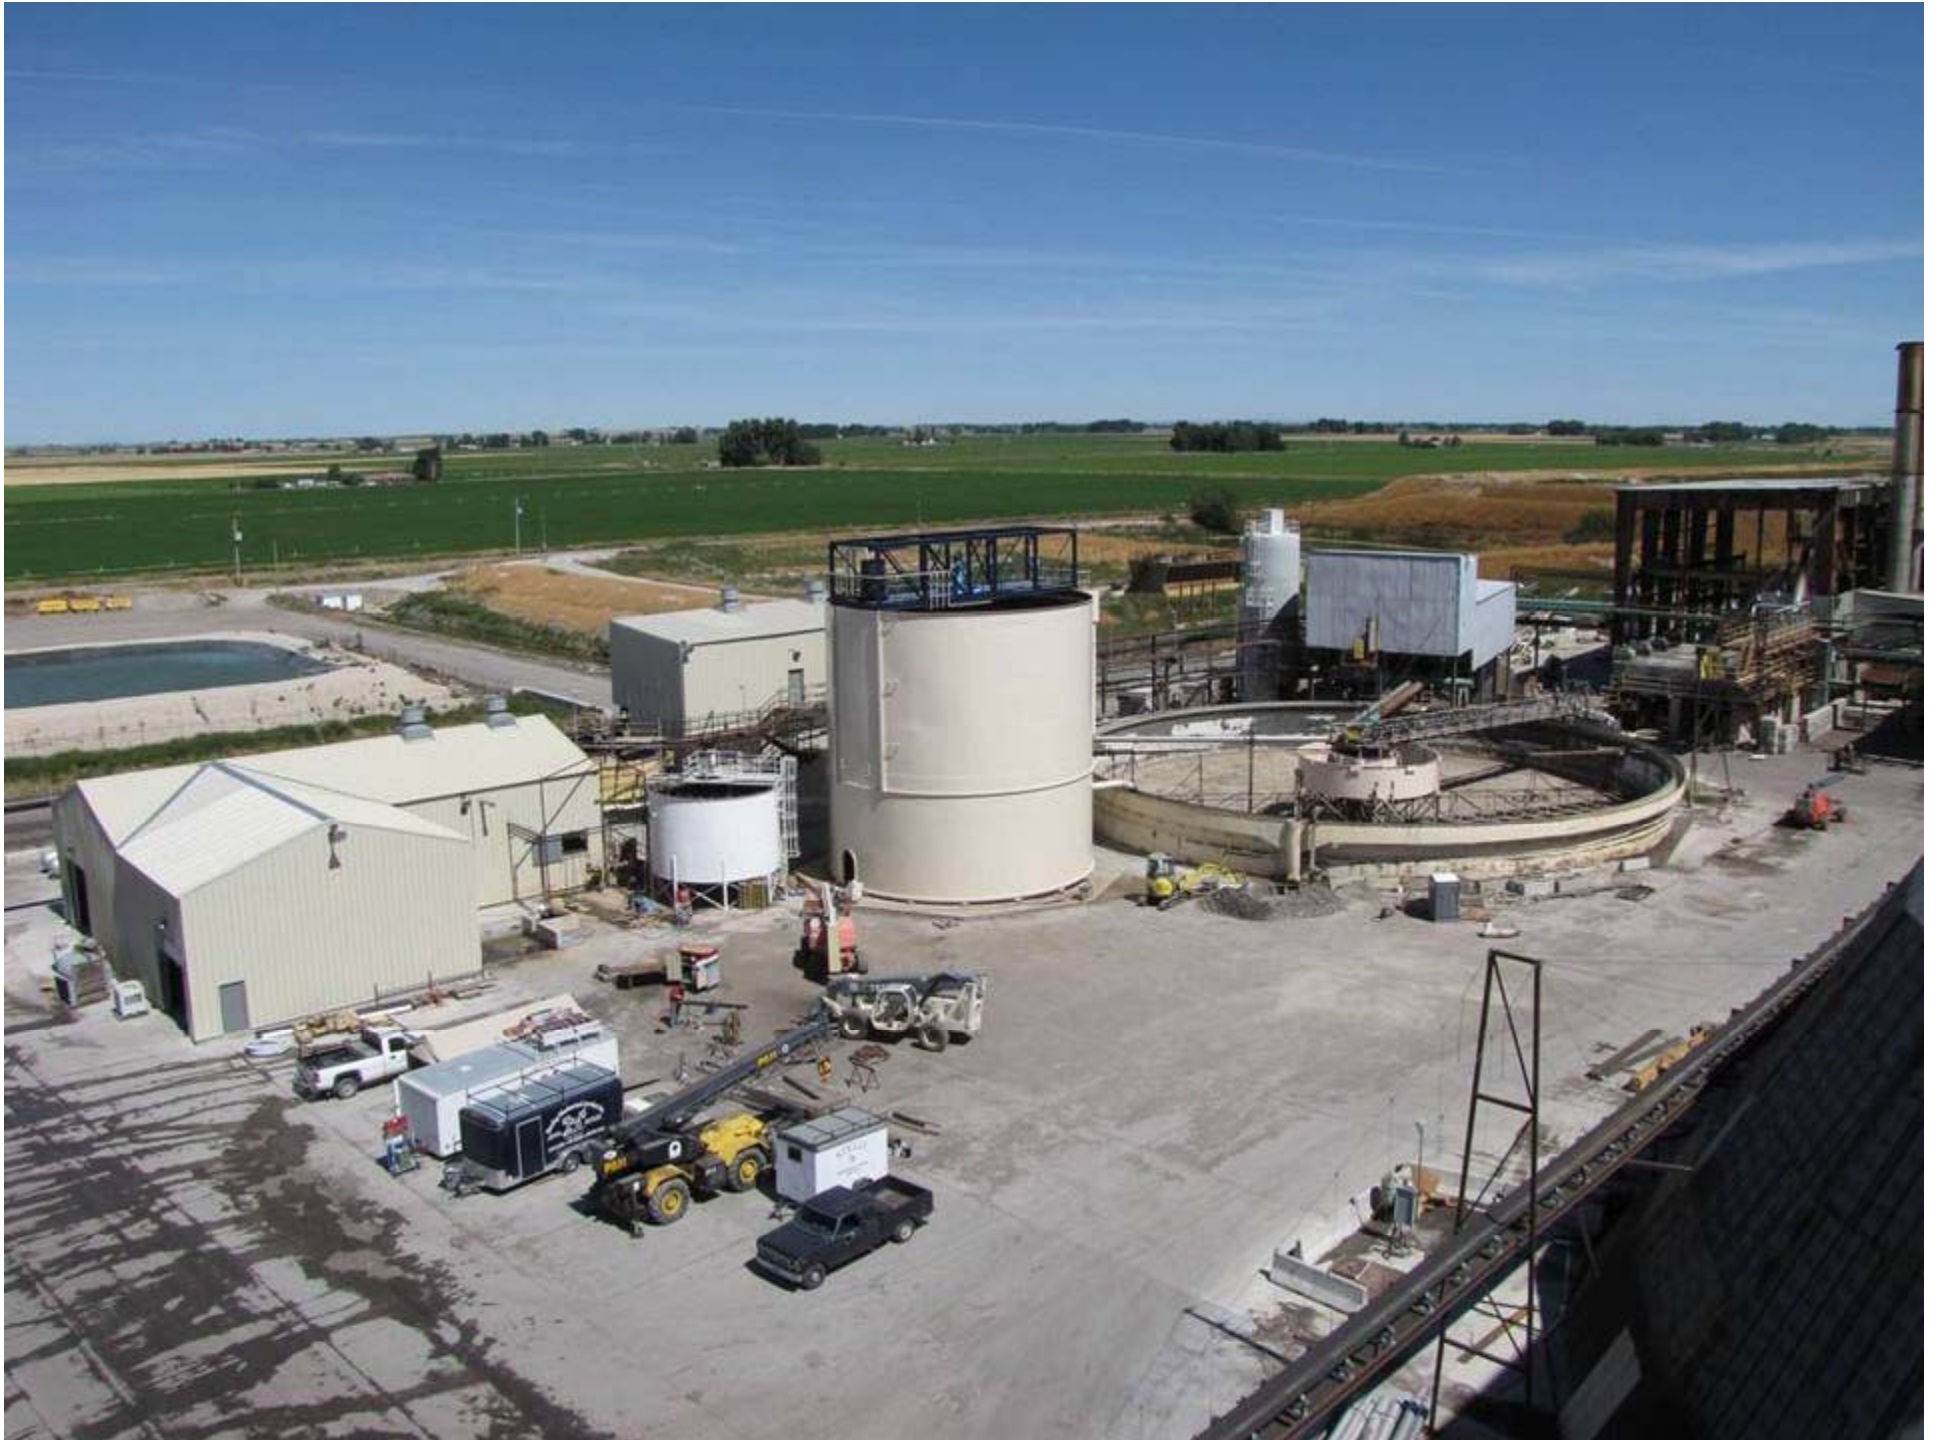
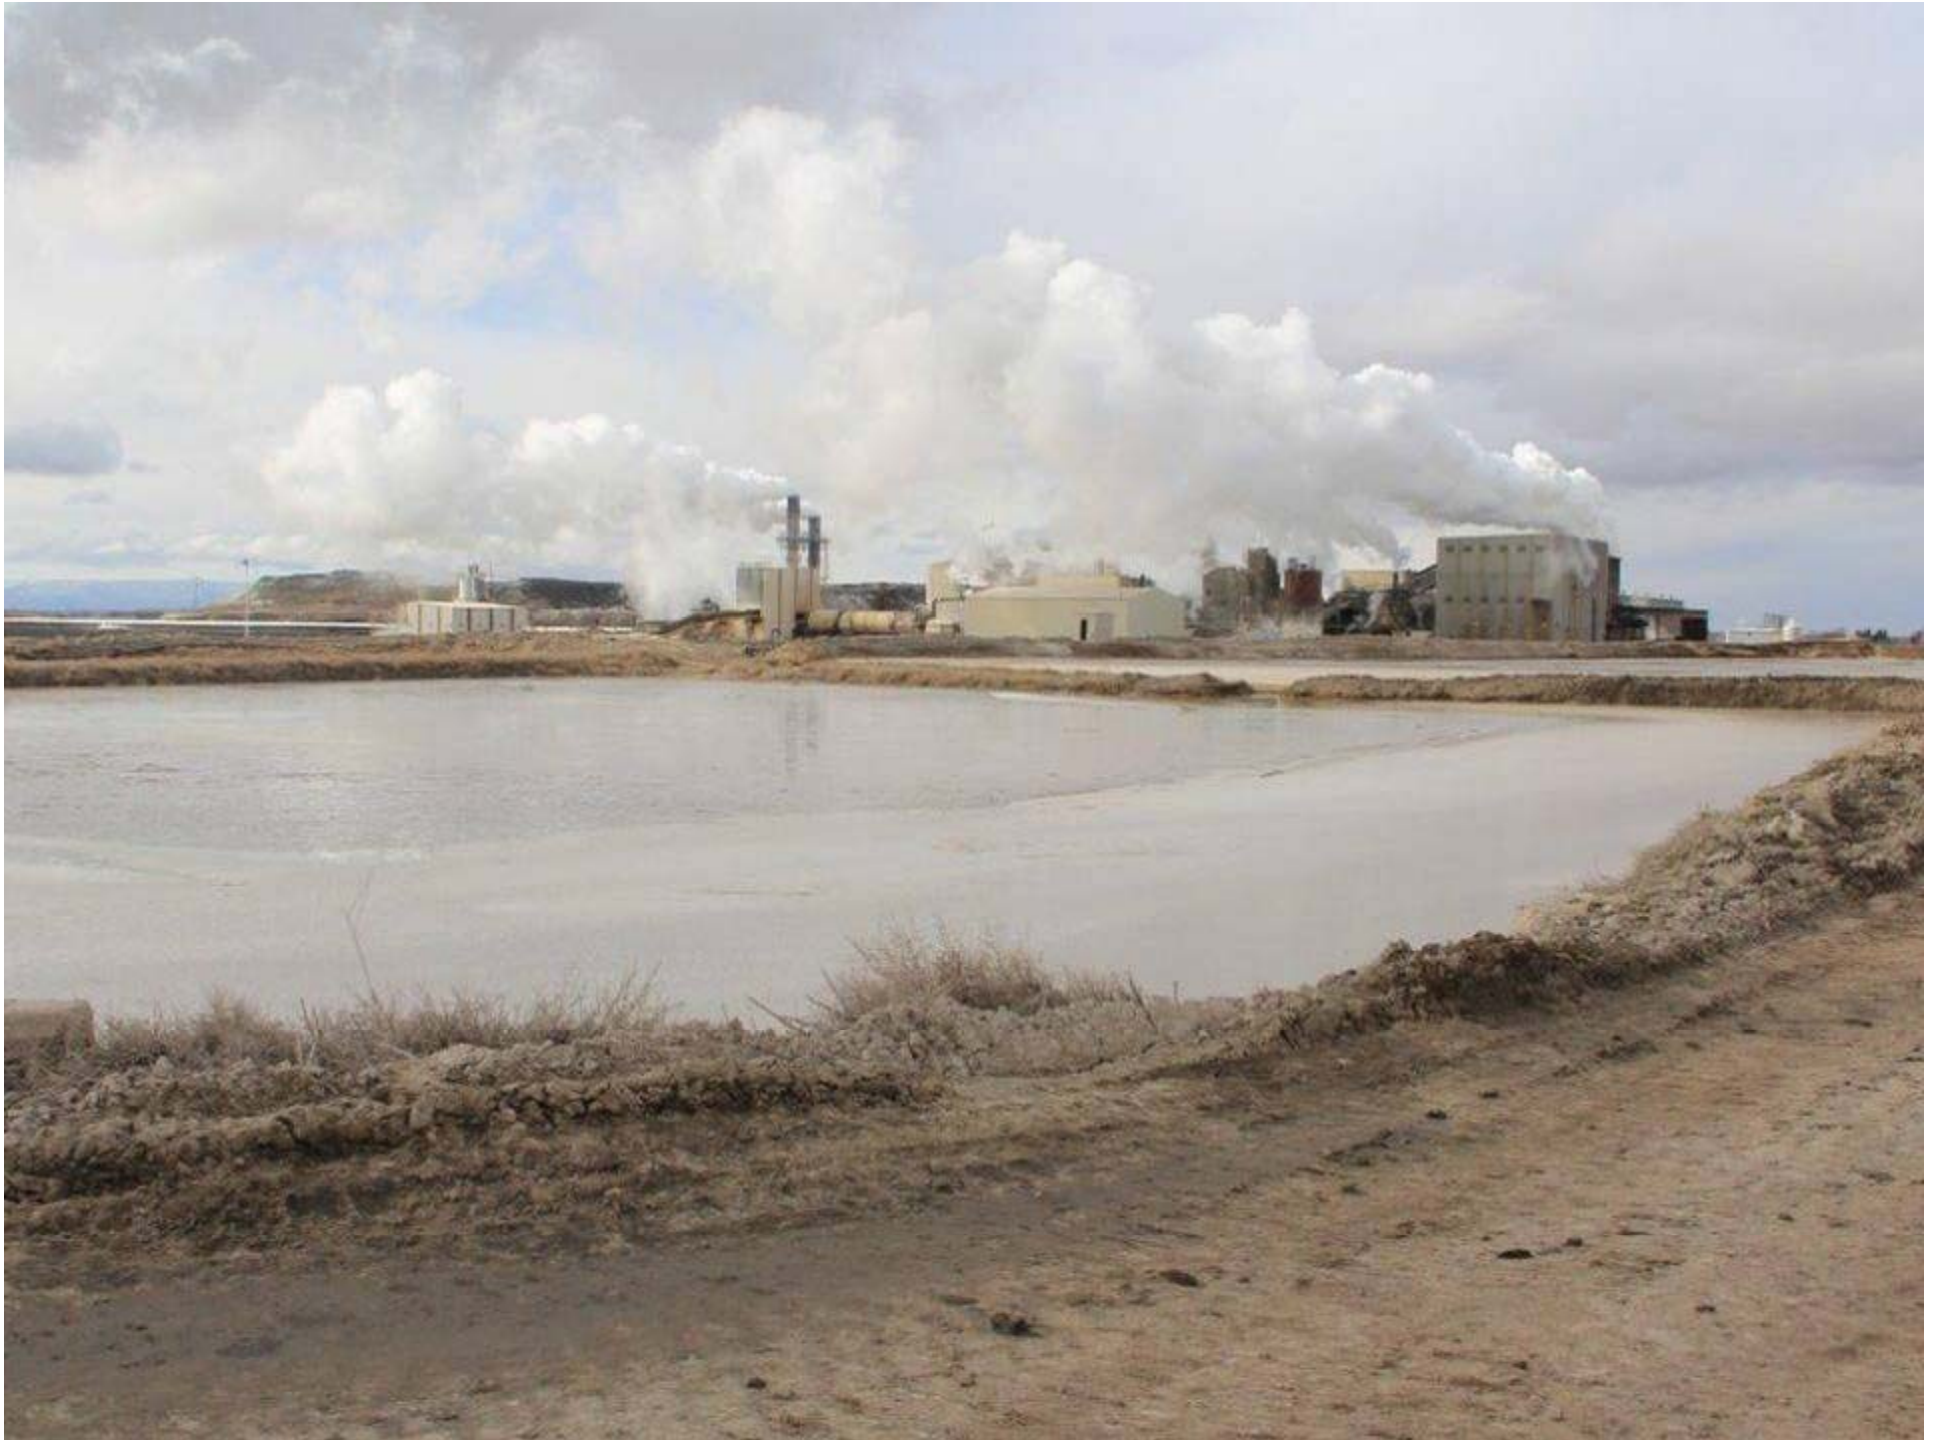
-Thickener Installed

**-Reduced the Volume of Water
with the Mud**
